SAVUKA STOPE SUPPORT TESTING FACILITY

NEWSLETTER

Issue No.3, August 2002

Tests Performed during July 2002

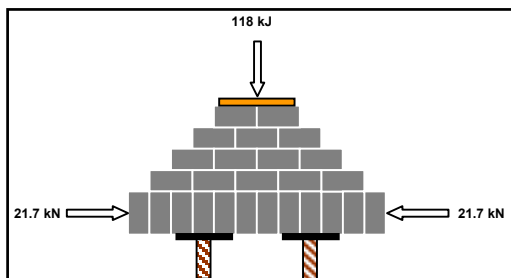
On 9 July 2002, two drop tests were conducted on the new Omni 150 sacrificial hydraulic prop units supplied by ELBROC. The support units were spaced 1.25 metres apart. Headboards were installed on top of the props, allowing two blocks to move freely in between the support units (Figure 1).

Figure 1: Test 6 configuration.

The drop weight was released from a height of 1.2 metres, which imparted

118 kJ of energy to the load distribution pyramid, with an impact velocity of 4.85 m/s.

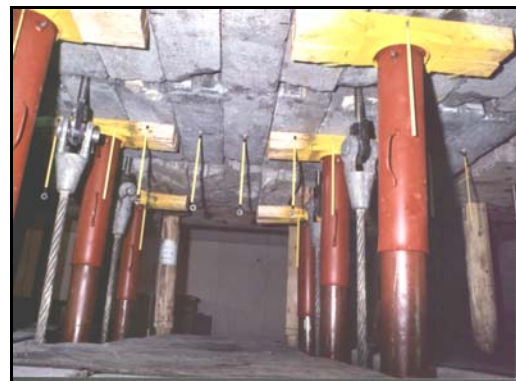
Figure 2: The support system before the first drop test from a height of 1.2 metres.

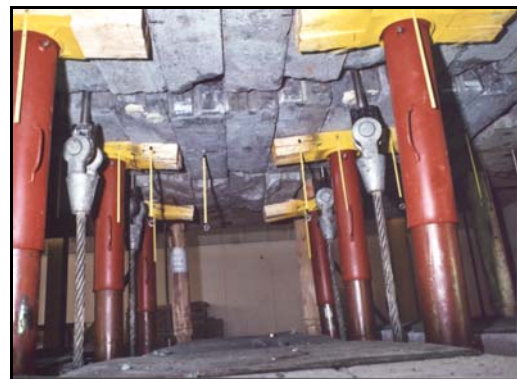
The support system performed well, not allowing any blocks to be dislodged from the hangingwall beams.

Figure 3: During the energy impulse no blocks were dislodged into the stope area.

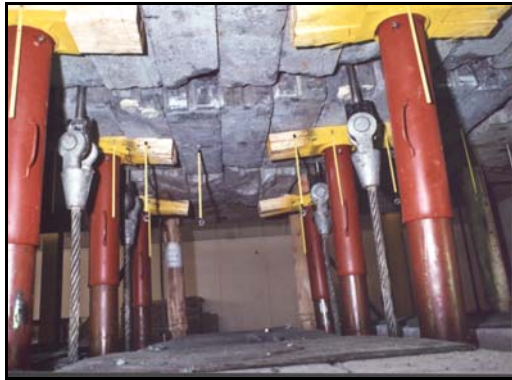
Figure 4: The conditions of the props and hangingwall beam after the first drop test.

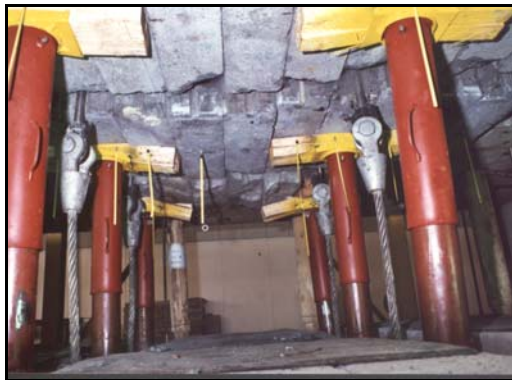
A second drop was performed on the deformed hangingwall beams and support system. The drop was identical to the first drop. No blocks were dislodged from the hangingwall beam during the second drop test (Figure 5).

Figure 5: The condition of the hangingwall beam and props were still good after the second drop.

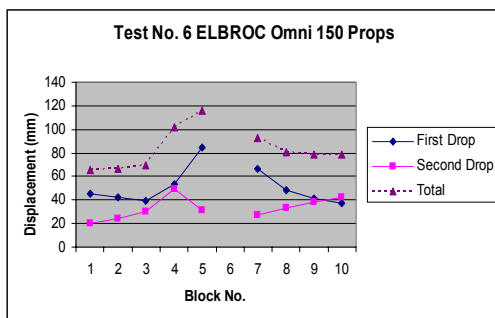
Figure 6: Plot of the block displacements during both drops.

No measurements were made for block No. 6, as the tape was dislodged during the first drop.

The first drop gave the most displacement with a maximum measured displacement of 85 mm. The second drop from the same height caused a further 49 mm of displacement, giving a total displacement in the blocks of 116 mm (Figure 6).

The displacements measured after each drop test are presented in Figure 6 and 7.

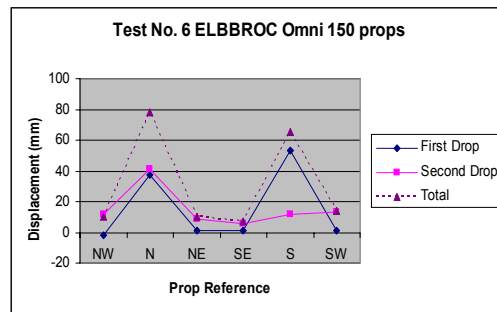
The displacements experienced by the individual hydraulic props were also measured during the two drops (Figure 7).

Figure 7: The displacement as measured on the individual support units.

The north and south props supporting the central beam showed a maximum displacement of 53 mm during the first drop and 41 mm during the second drop.

The total displacement measured in the north prop unit was 78 mm after both drops.

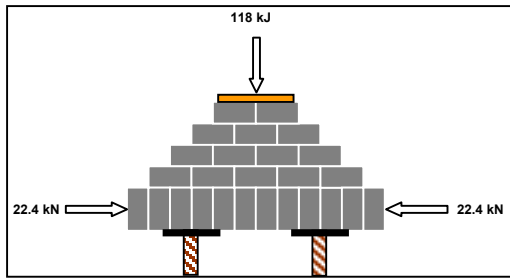
Test 7 was conducted on 18 July 2002, which involved a second round of drop tests on the ELBROC Omni 150 props. The support set up was identical to test 6 except that the spacing of the props had been moved further apart to 1.5 metres centre to centre.

Figure 8: Test 7 configuration.

The drop weight was dropped from a height of 1.2 metres, which imparted 118 kJ of energy to the load distribution pyramid, with an impact velocity of 4.85 m/s.

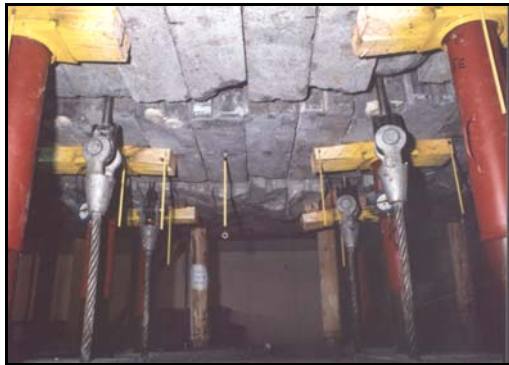
Figure 9: No blocks were dislodged after first drop.

A second drop test was conducted from the same height. No blocks were dislodged during either drop test. The central beam deflected towards the stope centre, while the ends lifted (Figure 9 and 10).

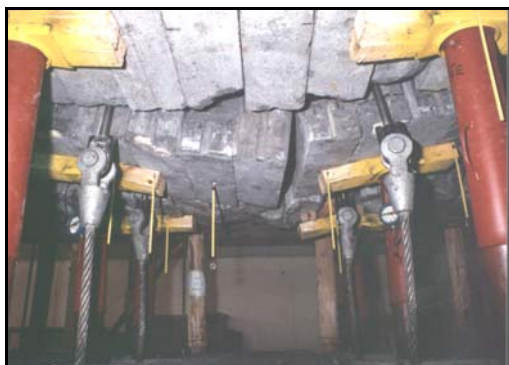
Figure 10: The hangingwall beam condition after the second drop, showing the central beam deflection.

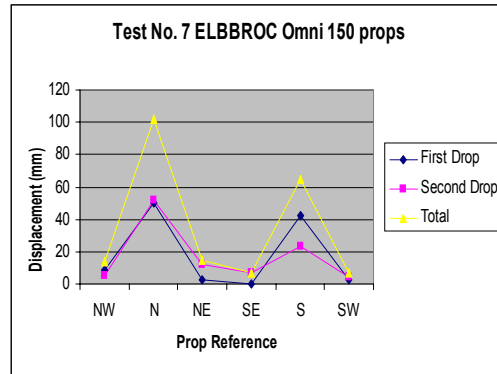
Figure 11: Displacement measured per individual support unit.

The maximum displacement measured in the north prop was 50 mm and 52 mm during the second drop, giving a total of 102 mm on the north prop, supporting the central beam.

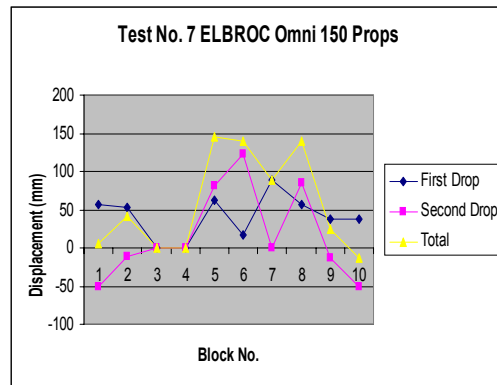
Figure 12: Displacement measured in the hangingwall blocks.

The maximum displacement in the blocks was 145 mm. During the second drop, outer blocks 1, 2, 9 and 10 of the central beam moved upwards as the beam deflected downwards in the middle (Figure 12).

No tapes were installed on blocks 3 and 4, due to interference with the load gauges installed on two of the hydraulic props. The objective was to record the maximum load generated in the hydraulic props during the drop test. Unfortunately, both gauges did pass the test, due to their maximum being exceeded during the drop test.
